Manhole Inspection Summary

Manhole # S29K__015MH

Insp Date: **10/29/08 12:35 PM**

Location Address: **705 Portland St.**

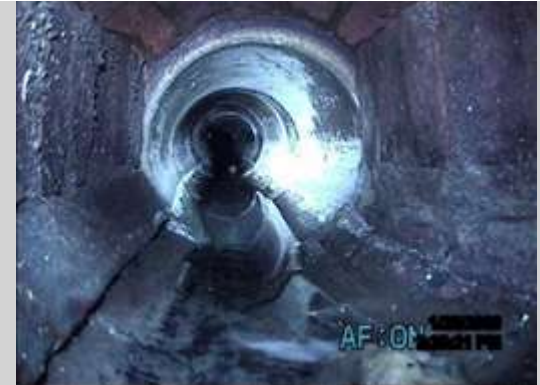
12 O'Clock Outflow

8 in. Circular Gravity Sewer
Pipe Out @ 12 O'Clock

Infiltration: **None** Pipe Seal Cond: **Sound**

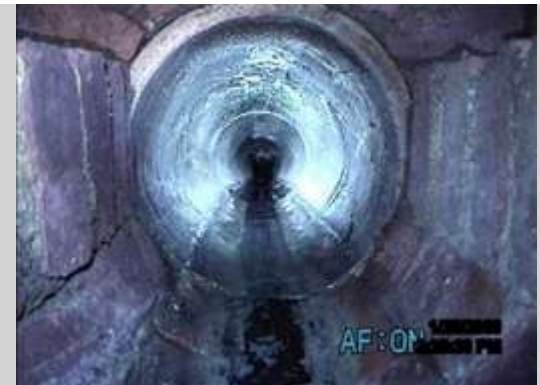
3 O'Clock Inflow

8 in. Circular Gravity Sewer
Pipe In @ 3 O'Clock

Infiltration: **None** Pipe Seal Cond: **Sound**
